Manhole Inspection Summary

Manhole # S25E__027MH

Insp Date: **8/7/07 8:20 AM**

Location Address: **1212 CAREY-ALLEY-CARROLLTON** Cross Street: **SARATOGA ST**

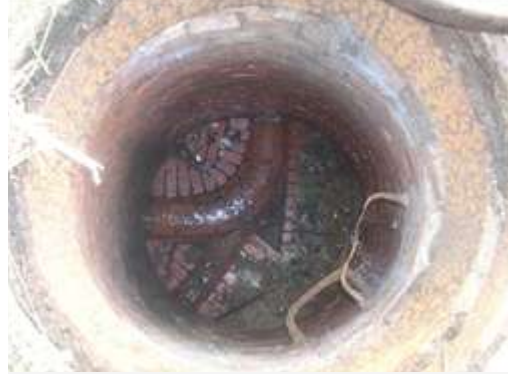
Top View

Cover Shape: **Circular** Diameter: **24** (in.) Length: (in.) Dist A/B Grade: **0** (in.)
Type: **Sanitary** Condition: **Sound** Cover Material: **Cast Iron**
Properties: ☐ Bolted ☐ Vented ☐ Water Tight ☐ Water Tight Insert

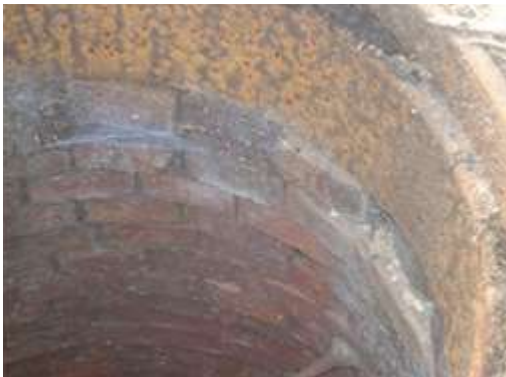
Defect 2

Chimney / Frame Adjustment ☒ Exists Material: **Brick** ☐ Parged Height: **3** (in.)
Condition: ☐ Sound ☐ Cracked ☐ Root Intrusion ☐ Loose Brick ☒ **Deteriorated**
Infiltration: ☒ None ☐ Joint ☐ Cracks ☐ Mortar ☐ Roots ☐ Wall

DETERIORATION OF CHIMNEY

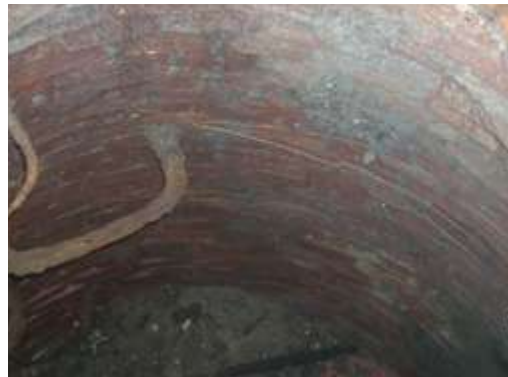
Defect 3

Corbel Material: **Brick** ☐ Parged Type: **Concentric/Eccentric**
Condition: ☐ Sound ☐ Cracked ☒ **Root Intrusion** ☐ Loose Brick ☐ Deteriorated
Infiltration: ☒ None ☐ Joint ☐ Cracks ☐ Mortar ☐ Roots ☐ Wall

ROOT INTRUSION (CORBEL)

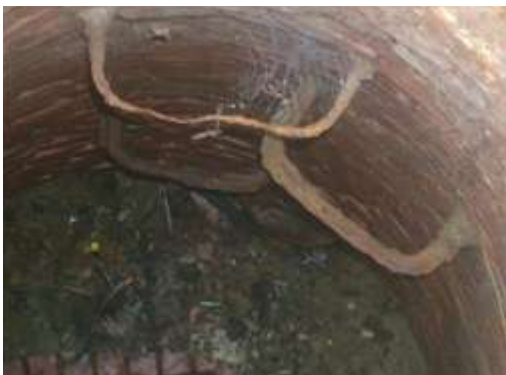
Defect 1

Steps Count: **4** Missing: **0** ☒ **Corroded**

CORRODED STEPS

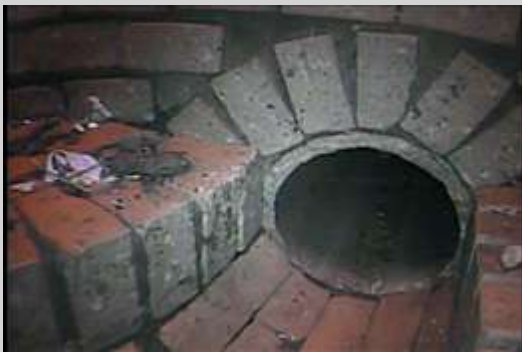
12 O'Clock Outflow

8 in. Circular Gravity Sewer
Pipe Out @ 12 O'Clock

Pipe Height: **8.4** (in.) Rod and Bar (Angled)
Pipe Material: **Clay** ☐ Pipe Lined
Invert Depth: **8.48** (ft.) Flow Characteristics: **Slow**
Deposits: ☒ None ☐ Mud ☐ Sludge ☐ Debris ☐ Grease
Silt Depth: (in.) Deposits Extent:
Infiltration: **None** Pipe Seal Cond: **Sound**

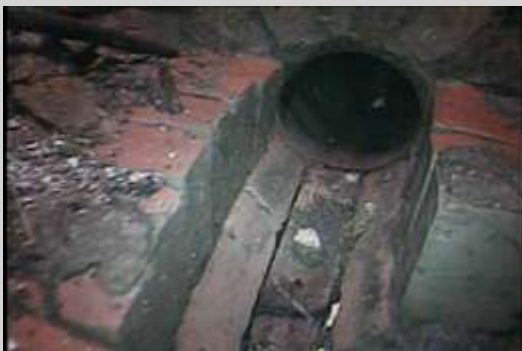
7 O'Clock Inflow

6 in. Circular Gravity Sewer
Pipe In @ 7 O'Clock

Pipe Height: **6** (in.) Rod and Bar (Angled)
Pipe Material: **Clay** ☐ Pipe Lined
Invert Depth: **7.90** (ft.) Flow Characteristics: **Slow**
Deposits: ☒ None ☐ Mud ☐ Sludge ☐ Debris ☐ Grease
Silt Depth: (in.) Deposits Extent:
Infiltration: **None** Pipe Seal Cond: **Sound**

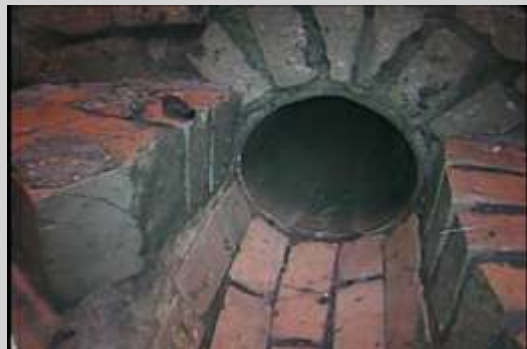
9 O'Clock Inflow

8 in. Circular Gravity Sewer

Pipe In @ 9 O'Clock

Pipe Height: **8.4** (in.) Rod and Bar (Angled)

Infiltration: **None** Pipe Seal Cond: **Sound**
